# Effect Of Polymicrobial Peri-Implant Plaque On The Morphological Degradation And Titanium Ion Leaching Of The Zimmer Biomet Osseotite Implant

Peri-implantitis, a biofilm-mediated disease, is a major cause of late implant failure. This in vitro study investigated the degradation of a high-roughness titanium dental implant (**Zimmer Biomet Osseotite, dual-acid etched surface**) exposed to patient-derived polymicrobial plaque. Ten sterile implants were incubated individually with plaque samples collected from patients (n=10) diagnosed with mild/moderate peri-implantitis for 30 days. Microbial analysis identified six predominant species, with alpha-Haemolytic Streptococcus (40%) being the most prevalent. All tested species (100%) showed Sulphur-reducing and Iron-oxidizing activities, indicative of high corrosive potential. Scanning Electron Microscopy (SEM) revealed severe surface degradation, including a statistically significant increase in thread diameter (**1.3 +/- 0.04 um**) and extensive formation of interconnected pits and fissures. Cracks were predominantly observed on the abutment (**70.0%**). Inductively Coupled Plasma Atomic Emission Spectroscopy (ICP-AES) confirmed the r

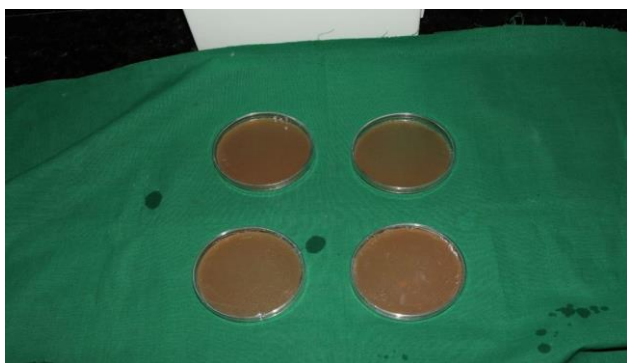
Figure-1 showing magnesium oxidizing media

Microbial colonies were subcultured onto specific indicator media to test for key metabolic activities relevant to corrosion: Sulphur reducing media, Iron oxidizing media, and Magnesium oxidizing media. Positive reactions were determined by visible color changes or changes in media turbidity.

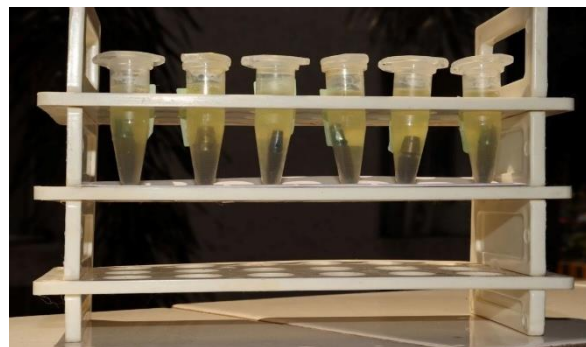
Figure-2 showing the implant incubated in the broth

Aliquots (1 ml) of Thioglycollate broth were taken in 1.5 ml Eppendorf tubes. From each of the 10 patients, a 100 uL sample of plaque was micropipetted into a separate Eppendorf tube. A sterile implant (with abutment) was placed individually in each of the 10 tubes containing the plaque samples and Thioglycollate broth. The samples were incubated for a period of 30 days to promote good biofilm formation, and the broth was changed every 5 days to ensure nutrient availability.
